Microscopic and statistical evaluation of the marginal defects of composite restorations: in vitro studies

KEYWORDS: composite restoration, stereomicroscope, marginal adaptation

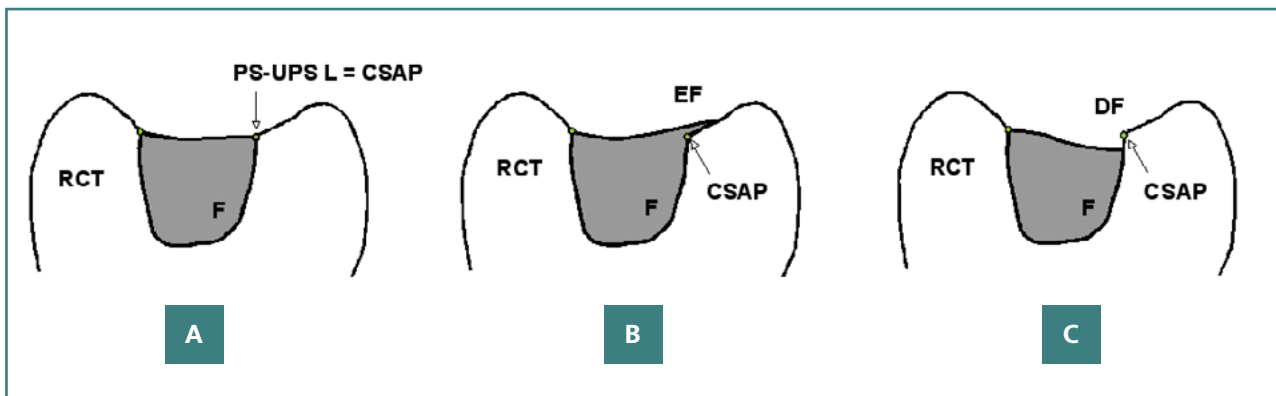
Figure 1. Diagrams illustrating vertical sections of molar crowns with Class I restorations, depicting correct and incorrect restoration placements. A, Correct filling demonstrating optimal marginal adaptation; B, Overextended filling (EF) where the composite material extends beyond the cavosurface angle point (CSAP); C, Underextended filling (DF) where the composite material fails to reach the CSAP. Key: F, filling; RCT, remaining coronal (hard) tissue; PS-UPS L, prepared surface-unprepared surface limit; CSAP, cavosurface angle point.

Fillings were assessed based on their placement at the interface between the prepared cavity surface and the external enamel surface of the tooth (Figure 1 A-C). Ideally, the composite material should align perfectly with the cavity margin, whether beveled or not. Deviations from this ideal included overextended (excess) or underextended (deficit) fillings: overextended fillings (Figure 1B) were characterized by composite resin extending beyond the prepared surface limit onto the unprepared surface, while underextended fillings (Figure 1C) were characterized by insufficient composite resin, failing to cover the entire prepared surface, leaving a portion exposed.

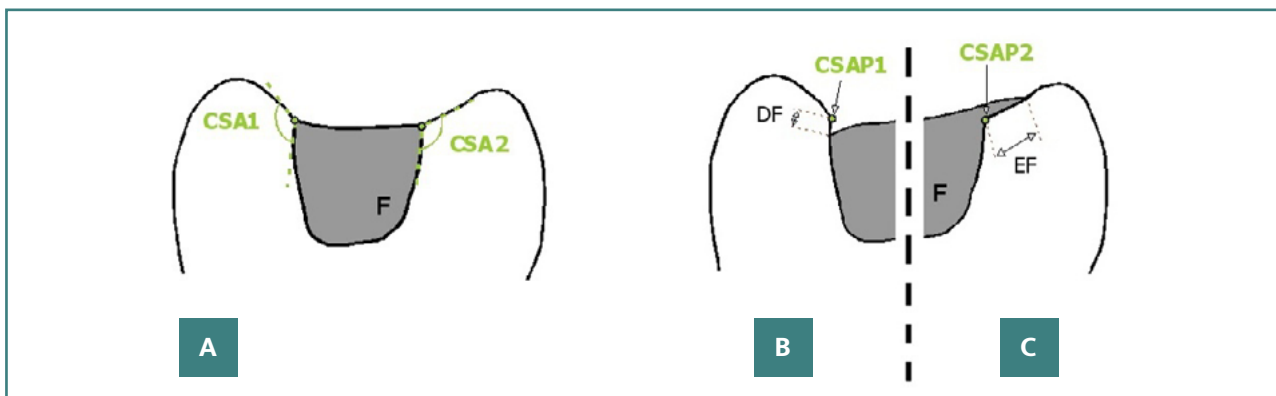
Figure 2. Diagrams of vertical sections through lateral tooth crowns with Class I restorations, illustrating marginal placement accuracy. A, Correct restorations, highlighting the cavosurface angle and its apex; B, Underextended restorations, with measurements indicating the distance from the filling's endpoint on the internal cavity wall to the point it should extend, corresponding to the cavosurface angle tip; C, Overextended restorations, with measurements showing the length of the external crown surface inadvertently covered by the restoration material.

lustrated in Figure 2A. For underextended fillings, the uncovered length from the expected filling margin to the cavosurface angle apex was measured (Figure 2B). For overextended fillings, the excess composite length from the cavosurface angle to the filling's end on the unprepared surface was measured (Figure 2C). These measurements facilitated the analysis of marginal adaptation quality in the restorations.

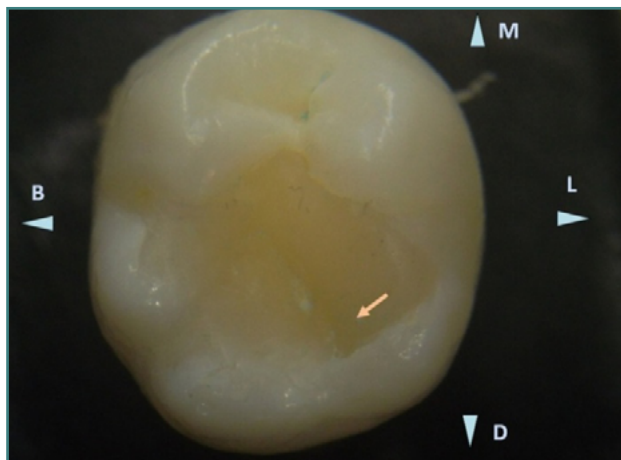
Figure 3. Occlusal view of mandibular third molar (tooth 38) with an extended occlusal composite restoration. The color contrast between the enamel and composite resin allows for clear stereomicroscopic detection of restoration boundaries. The distolingual cusp shows incorrect restoration with a negative relief (ledge) indicated by the arrow. Reflected light stereomicroscopy, magnification 10x. B, buccal; L, lingual; M, mesial; D, distal.

The first case is a mandibular third molar, 38, with a defective Class I filling (Figure 3), presenting an extended occlusal composite restoration. Stereomicroscopic examination (10x magnification) revealed distinct color differences between the enamel surface and the composite resin, which allowed for precise detection of the restoration limits. Multiple deficiencies were identified. In the mesial part of the crown, fibers were inadvertently included in the composite material, indicating improper handling (Figure 4, Arrow 1). Additionally, the cavity edge was irregular due to inadequate finishing during the preparation phase, resulting in a poorly defined cavosurface margin (Figure 4, Arrow 2).

The distal part of the crown showed improper restoration of the distolingual cusp's internal slope (Figure 3). There was also an excess of composite material over the distal marginal ridge (Figure 5), which can contribute to mechanical failures under masticatory forces. In the buccal part of the crown, excess composite material was found covering the intercuspital groove. This excess was fractured, leaving a ledge on the distal aspect (Figure 6). Such defects suggest contamination and improper handling during the restoration process, compromising the marginal seal and structural integrity of the restoration.

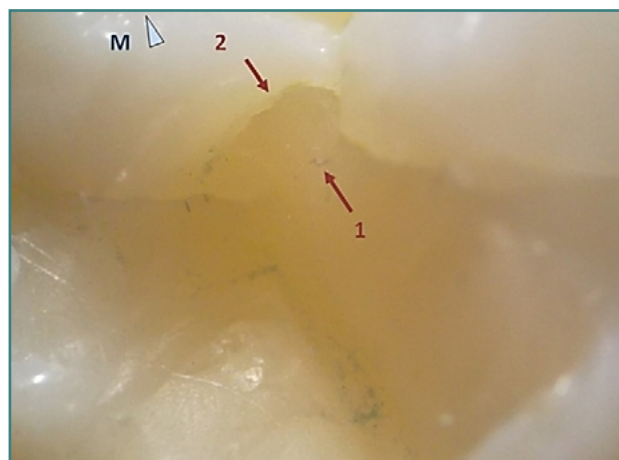
Figure 4. Detailed view of the mesial limit of the occlusal restoration on tooth 38. Arrow 1 highlights accidental fibers embedded in the composite material, while Arrow 2 indicates a ledge on the mesial aspect. Reflected and transmitted light stereomicroscopy, magnification 20x.

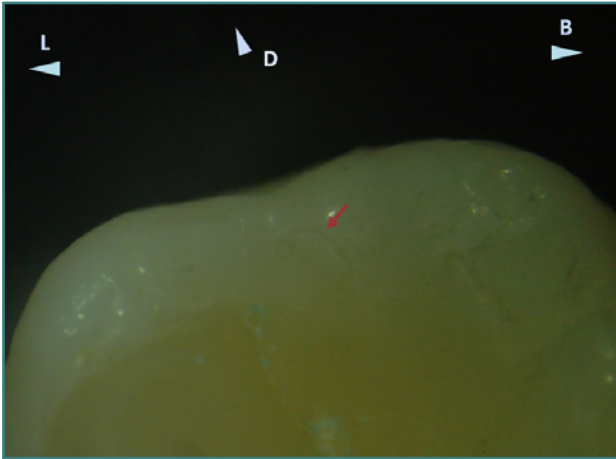
Figure 5. Distal aspect of the occlusal surface of tooth 38, showing a slight excess of restorative material near the distal marginal ridge. Reflected light stereomicroscopy, magnification 20x. B, buccal; L, lingual; D, distal.

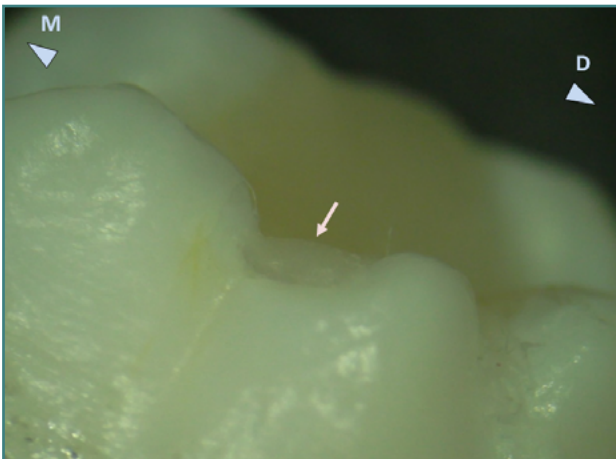
Figure 6. Buccal view of the occlusal composite restoration on tooth 38. Excess composite material is present in the interscupal groove and is fractured, leaving a small ledge on the distal part. Reflected light stereomicroscopy, magnification 12.5x. M, mesial; D, distal.

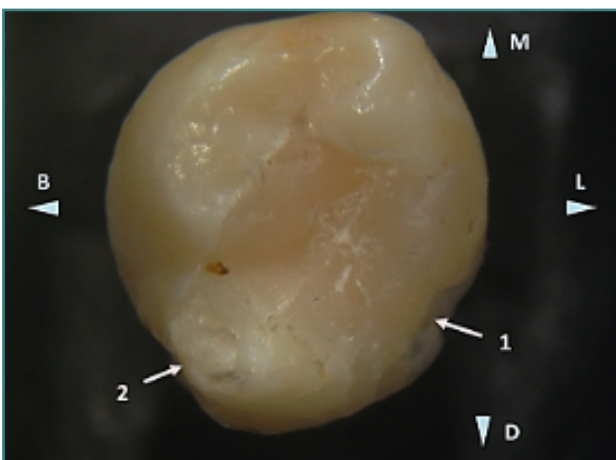
Figure 7. Occlusal image of mandibular second molar (tooth 37) showing a large occlusal restoration that initially restored the distolingual cusp, which is fractured (arrow 1). A fracture is also visible on the distobuccal cusp (arrow 2). Reflected light stereomicroscopy, magnification 10x. B, buccal; L, lingual; M, mesial; D, distal.

The second case focused on a mandibular second molar (tooth 37) with a large occlusal filling extending onto the lingual surface. Initially, this restoration almost completely restored the distolingual cusp. However, stereomicroscopic examination revealed fractures in both distal cusps (Figure 7).

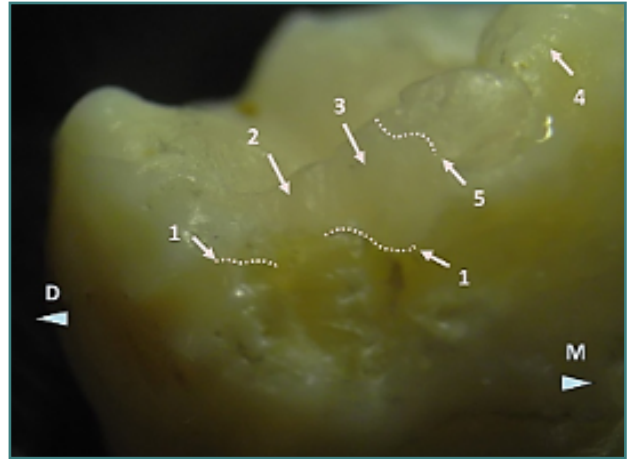
Figure 8. Detailed view of the fracture on the distolingual cusp of tooth 37. Arrow 1 marks the restoration-dental hard tissue limit with a dotted line. Arrow 2 indicates the surface of the fractured restoration, while Arrow 3 shows the unfractured restoration surface. Arrow 4 points to the enamel surface, and Arrow 5 indicates the border between the composite filling and the enamel. Reflected light stereomicroscopy, magnification 20x. M, mesial; D, distal.

Detailed examination of the fractured areas revealed a significant difference in the appearance of the fractured restoration surface compared to the intact restoration (Figure 8). A brown discoloration in the deepest part of the distobuccal cusp indicated dehiscence between the filling material and the enamel wall, contributing to structural weakness (Figure 7). Further fractures were identified at the base of the distolingual cusp (Figure 9), suggesting that occlusal trauma or improper restoration techniques may have caused these fractures.

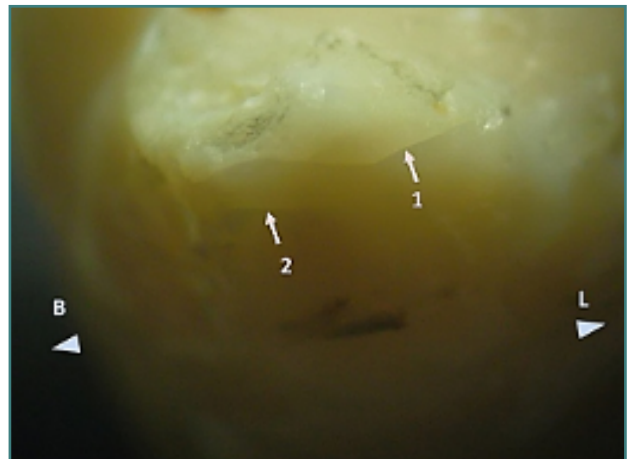
Figure 9. Detailed view of the distobuccal cusp of tooth 37, showing two relatively horizontal cracks at the base (arrows 1 and 2). These cracks, along with the enamel fracture at the cusp's top, suggest occlusal trauma. Reflected light stereomicroscopy, magnification 25x. B, buccal; L, lingual.

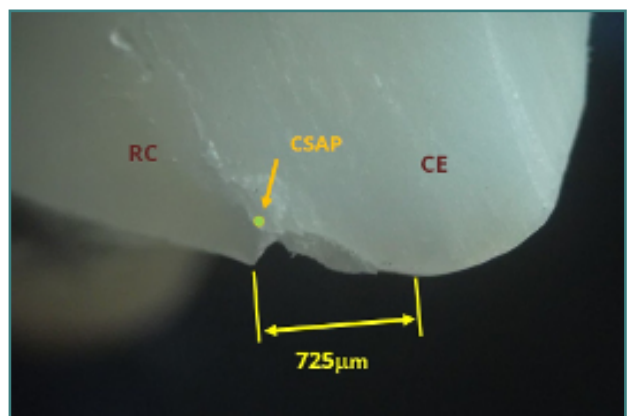
Figure 10. Fractured restoration at the vestibular cusp tip of tooth 15. The overextension amplitude of the composite material could not be evaluated due to the marginal loss of composite material. The position of the point corresponding to the apex of the cavosurface angle is approximately indicated. Reflected light microscopy, magnification 40x.

Figure 10 illustrates a case where part of the cusp was covered with a thin layer of composite without pre-existing marginal bev-

eling. This layer was fractured, preventing precise micrometric assessment of the excess material.

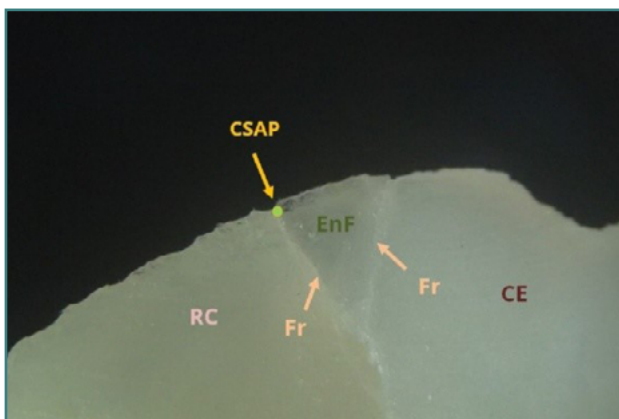
Figure 11. Restoration on tooth 35 showing a marginal enamel fracture near the cavosurface angle. An enamel fragment (EnF) is slightly detached, while no excess or deficit of material is observed. Reflected light microscopy, magnification 40x. EnF, enamel fragment; RC, resin composite; CE, cusp enamel; Fr, fracture; CSAP, cavosurface angle point.

Perfect marginal adaptation was rare. Even seemingly correct restorations often exhibited other defects, such as enamel fractures. Figure 11 shows a marginal enamel fracture in tooth 35, with a slightly detached wedge-shaped enamel fragment. Such fractures can arise from unsupported enamel prisms and occlusal interferences, compromising the restoration's clinical viability.

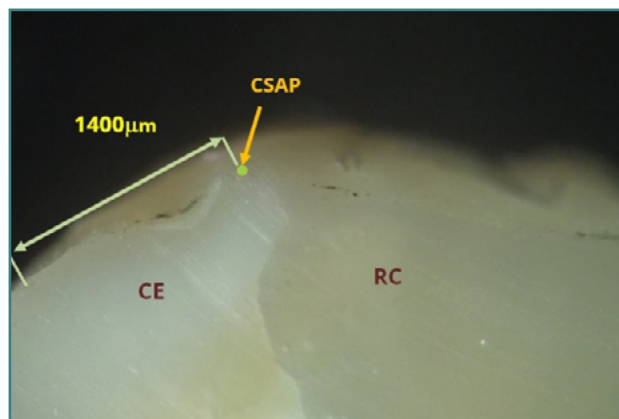
Figure 13. Overextended restoration on tooth 36, with the composite extending over the external surface of the molar without a beveling area. The overextension length is approximately 1400 μm . Reflected light microscopy, magnification 40x. RC, resin composite; CE, cusp enamel; CSAP, cavosurface angle point.

Figures 13 and 14 depict overextended restorations on non-beveled surfaces. Thin layers of material extended onto the external surface are prone to fracture under masticatory forces. Figure 13 shows an overextended restoration on tooth 36, extending approximately 1400 micrometers. Figure 14 depicts a Class II cavity on tooth 26 with a material deficit near the buccal cusp, measured at approximately 425 micrometers, which can promote secondary caries and occlusal interference.

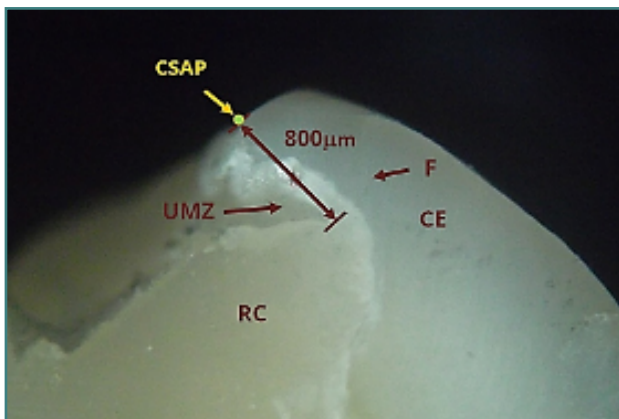
Figure 12. Underextended restoration on tooth 37, showing a vertical fracture of the buccal cusp. The material deficit, measured by micrometry, is approximately 800 μm . Reflected light microscopy, magnification 40x. RC, resin composite; F, fissure; UMZ, undermining zone (filling absent); CE, cusp enamel; CSAP, cavosurface angle point.

Figure 12 presents an underextended restoration where unsupported enamel was left unaddressed, leading to a vertical fracture of the buccal cusp over time. The material deficit was measured at approximately 800 micrometers.

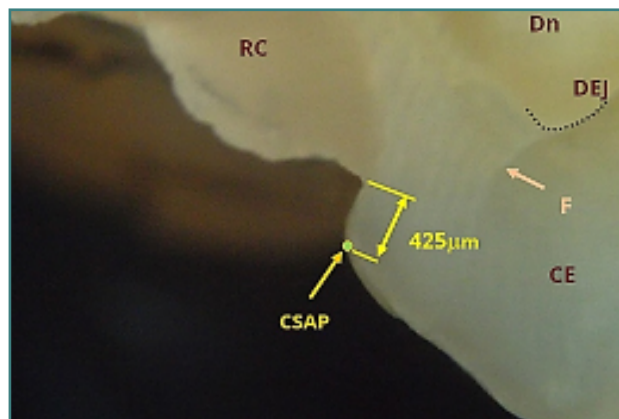
Figure 14. Class II cavity restoration on tooth 26 near the buccal cusp, showing a material deficit of approximately 425 μm . A vertical crack in the enamel (F) extends to the dentin-enamel junction (DEJ). Reflected light microscopy, magnification 40x. CSAP, cavosurface angle point; RC, resin composite; CE, cusp enamel; Dn, dentin; DEJ, dentin-enamel junction.

An error magnitude below 250 µm is ideal for marginal deficits, although challenging to achieve clinically, especially in distal arch areas. As illustrated in Figure 14, a 425 µm deficit affects marginal fit, potentially causing occlusal interferences. The cu-

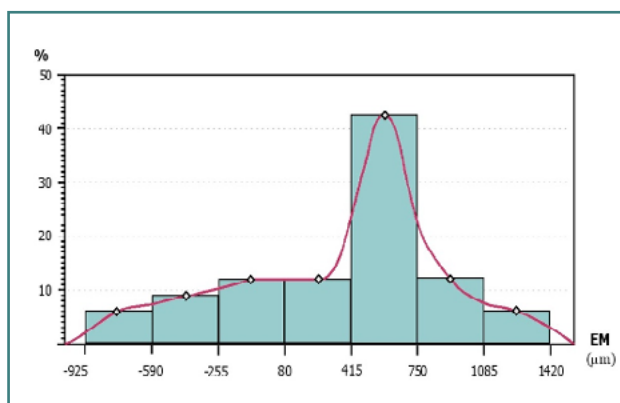
Figure 15. Histogram and frequency curve for the degree of marginal lack of adaptation obtained using micrometry. EM, error magnitude.

Figure 15 displays the histogram and frequency curve, illustrating the distribution of marginal adaptation deficiencies, while Figure 16 shows the cumulative frequency graph and curve, rep-

From the histogram, most maximum marginal adaptation errors fall within the 415-750 µm range. Achieving a marginal fit with an error magnitude below this value is challenging, even with magnification and precise handling of composite tools. Therefore, errors greater than 500 µm should be classified as clinical errors. The average marginal adaptation error in deficient areas was 364.3 µm, consistent with clinical experience indicating difficulty achieving sub-400 µm precision [20-22].

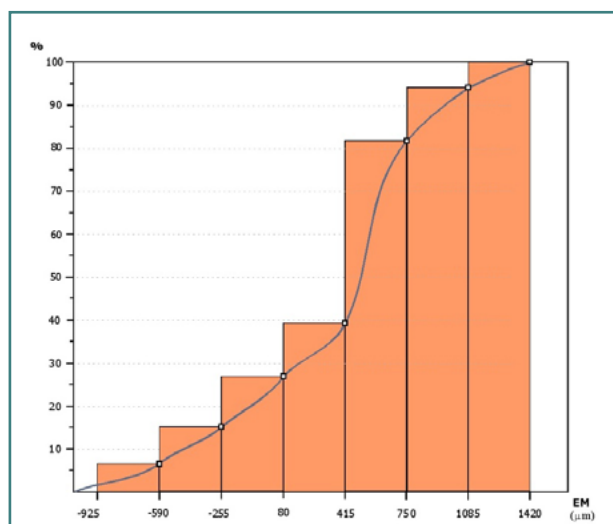
Figure 16. Cumulative frequency graph and cumulative curve for the degree of marginal lack of adaptation obtained using micrometry. EM, error magnitude.

representing the summed frequencies for each class interval. The histogram provides a visual depiction of data distribution, while the cumulative frequency graph illustrates the overall distribution pattern.

mulative frequency graph shows that approximately 20% of marginal adaptation errors are over 250 µm, with 15% considered clinical errors. About half of the errors are overextensions greater than 500 µm, indicating that overextension errors are twice as frequent as deficits.
